Abandoned Uranium Mine Site Assessment for the Varnum Site (NM0116)

FINAL REPORT

NM0116

INTERA Incorporated (INTERA) has prepared this Abandoned Uranium Mine (AUM) Site Assessment Report for the Mining and Minerals Division (MMD) of the New Mexico Energy, Minerals and Natural Resources Department (EMNRD) in compliance with the Professional Service Agreement dated November 2, 2009. INTERA visited the Varnum Site (AUM Site), MMD ID: NM0116, on February 26, 2010.

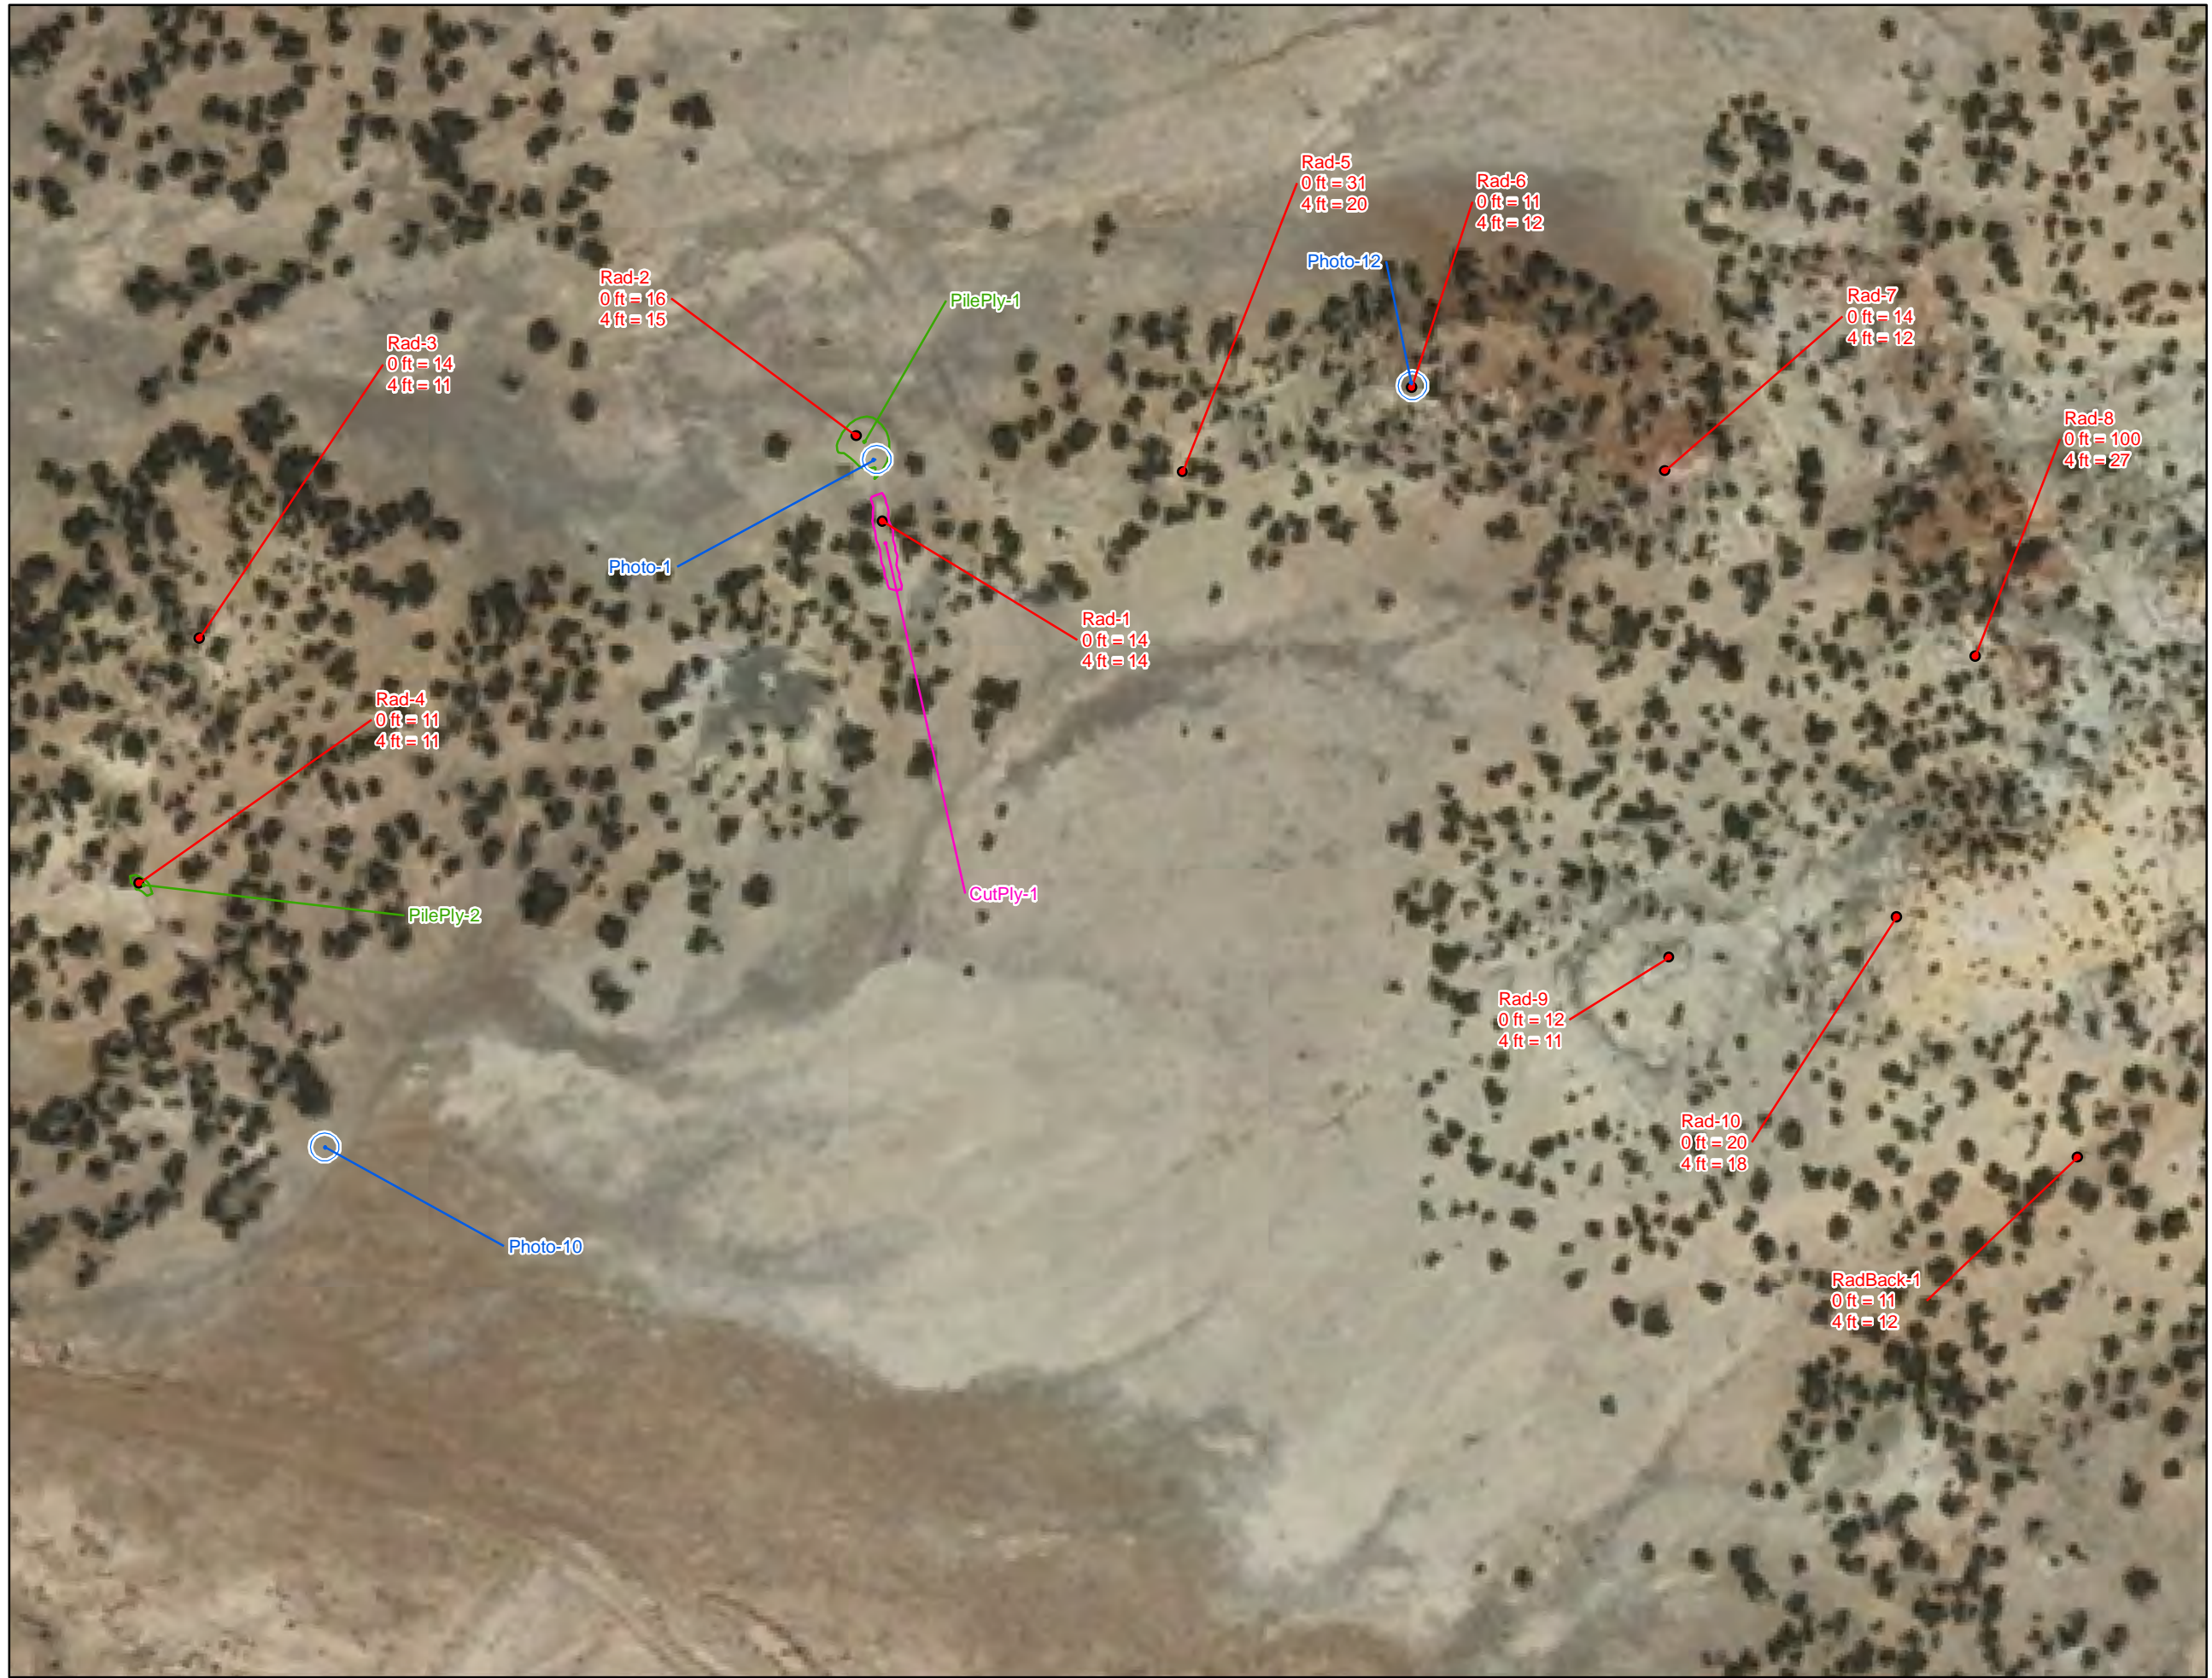
Figure 4a
Site Map on
Aerial Photo
NM0116-Varnum
Abandoned Uranium
Mine Assessment

One background gamma radiation reading was taken at the AUM Site, recording 11 $\mu\text{R/hr}$ at contact and 12 $\mu\text{R/hr}$ at 4 ft above ground. Please see Table 2 for all of the gamma radiation readings taken at the AUM Site and Figures 4a and 4b for the locations of the radiation readings.

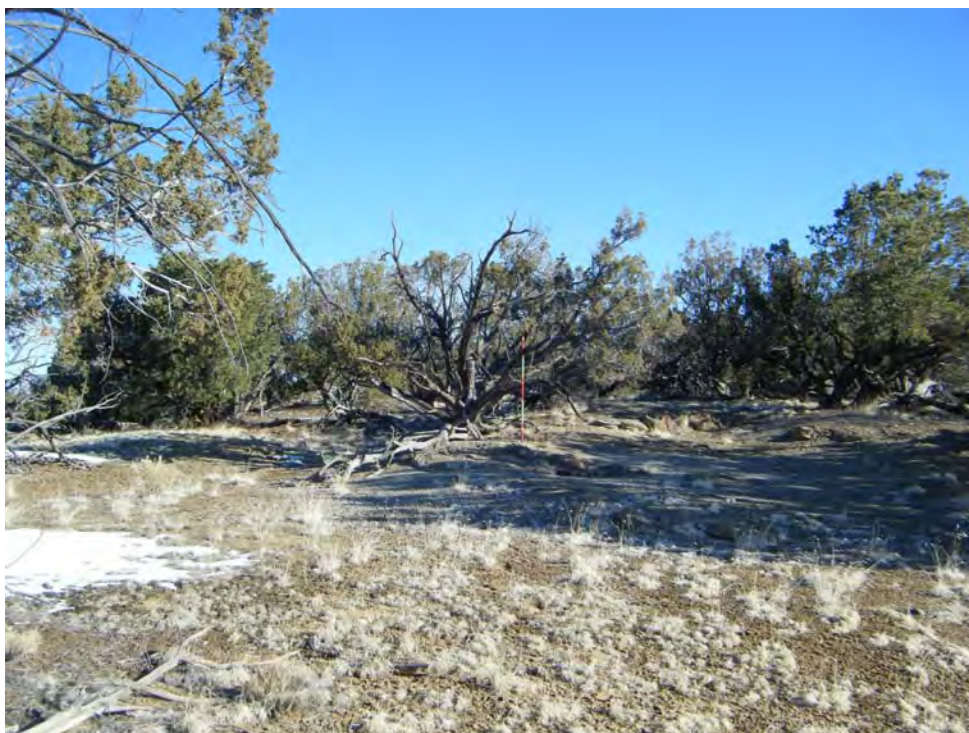
Photo 8-Site photo, looking north.

Photo 8 - site photo, looking N

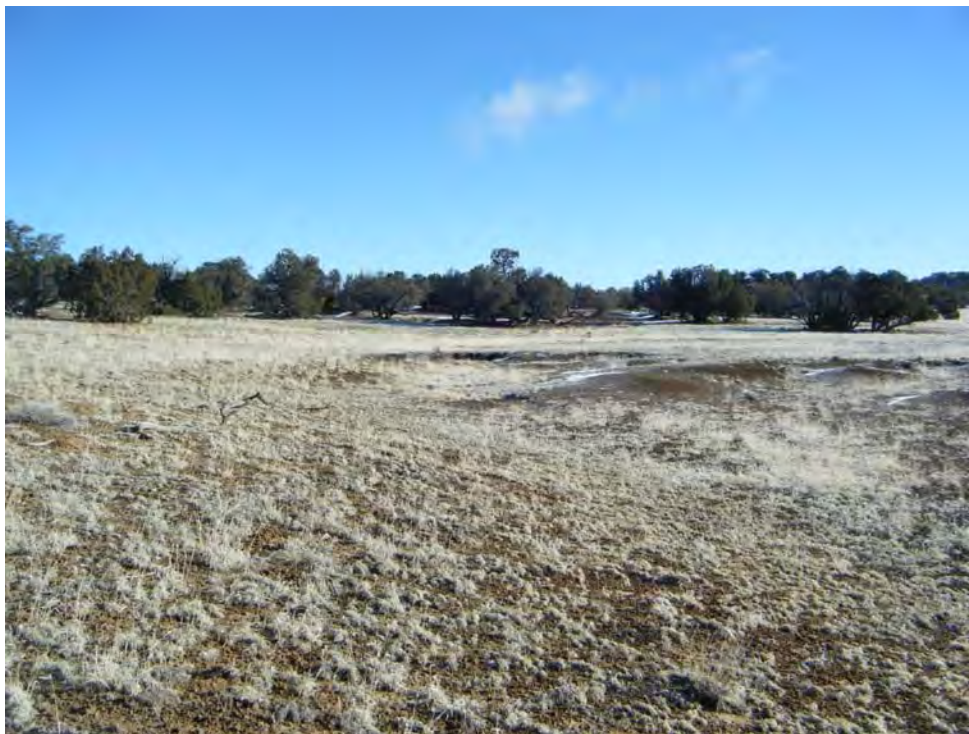
Photo 10-Site photo, looking northwest (point Photo-10).

Photo 10 - site photo, looking NW

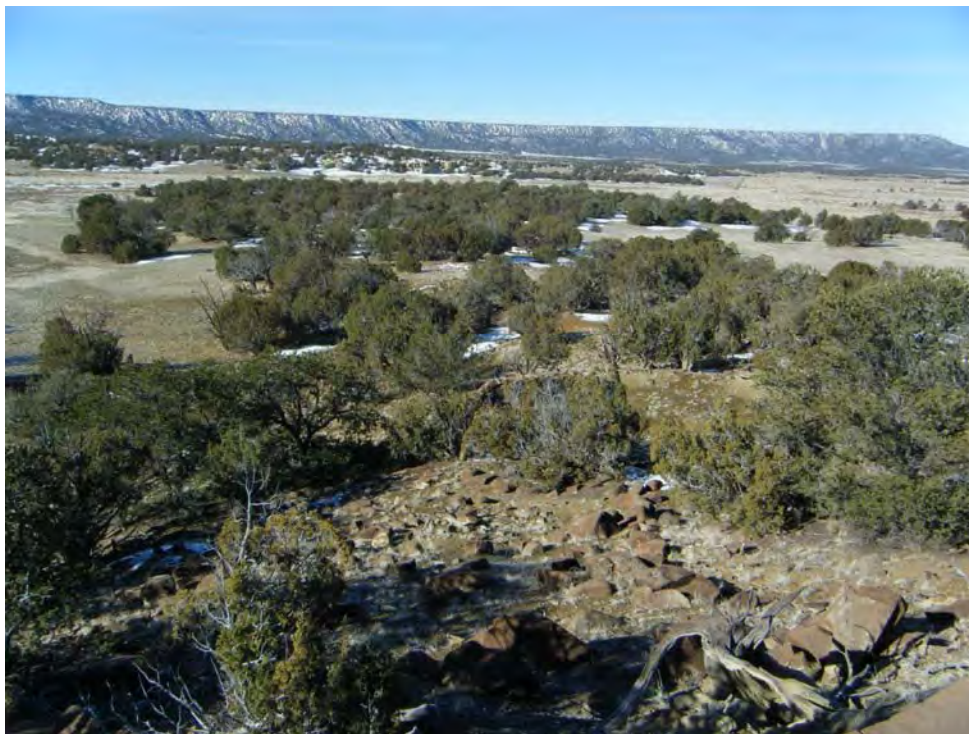
Photo 12-Looking down and west at the AUM Site from a nearby hill (point Photo-12).

Photo 12 - site photo looking down on area where first 3 mine features were found, looking W
